NASA Contractor Report 158969

**ASSESSMENT OF STATE-OF-THE-ART
OF IN-SERVICE INSPECTION METHODS
FOR GRAPHITE EPOXY COMPOSITE
STRUCTURES ON COMMERCIAL
TRANSPORT AIRCRAFT**

**Boeing Commercial Airplane Company
Seattle, Washington**

**Contract NAS 1-15304
January 1979**

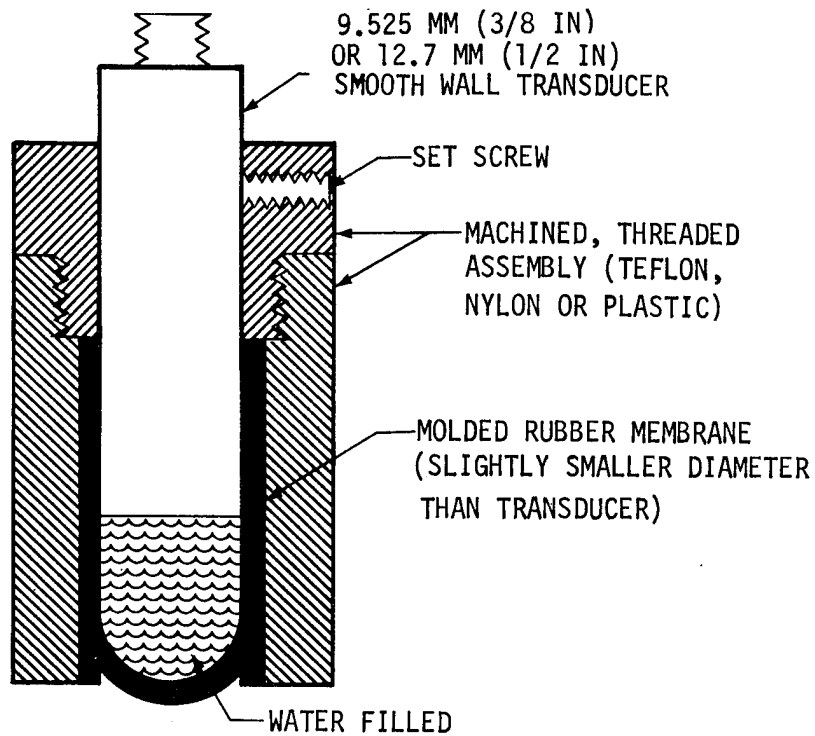
FIGURE 1. STAND-OFF SEARCH UNIT

- o Standard ultrasonic test instrument equipped with a high-resolution pulser-receiver unit for 5, 10, and 15 MHz transducers.
- o One each 5, 10, and 15 MHz high-resolution contact search units.
- o One each 5, 10, and 15 MHz transducers adaptable to angle beam shoes.
- o Angle beam shoes.
- o Couplant: oil, grease, commercial couplant. Also, water bubblers, squirters, and encapsulated water standoffs have been used. The latter is illustrated in figure 1.

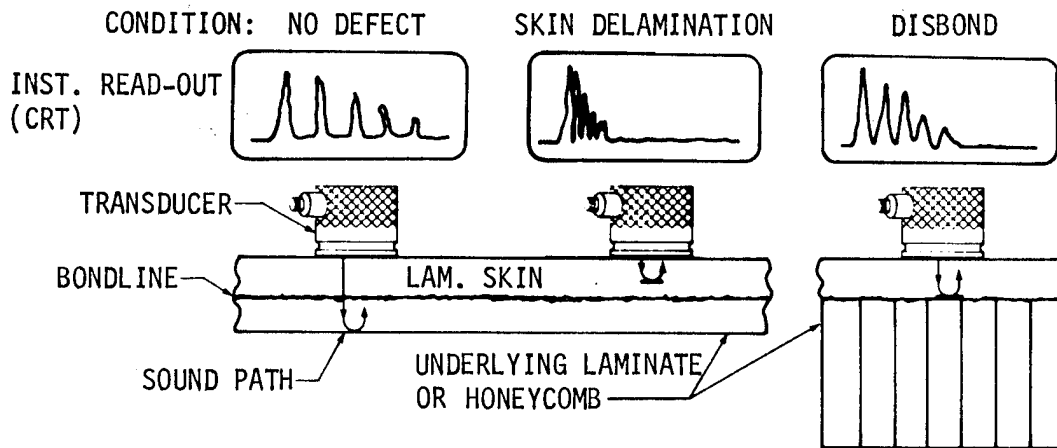
FIGURE 2. STRAIGHT BEAM TECHNIQUE

Two methods are described--the straight beam method and the angle beam method. Both are effective in detecting delaminations in the laminated composite skin and delaminations or disbonds at the skin-to-underlying structure interface. The angle beam method is applicable only to metal honeycomb. (It is unlikely that nonmetallic honeycomb will support sufficient sound transmission levels.) The straight beam method is applicable both to skin-to-honeycomb and skin-to-underlying laminate bonds. The two methods are illustrated in figures 2 and 3.

Using applicable instrument setup instructions and reference standards, verify instrument sensitivity with reference standard defects. It may be necessary to vary search unit assemblies using plastic shoes or encapsulated water standoff devices and various shoe angles for the angle beam method. Only certain frequencies or specific transducers may be usable on the structure and defect combination under investigation.

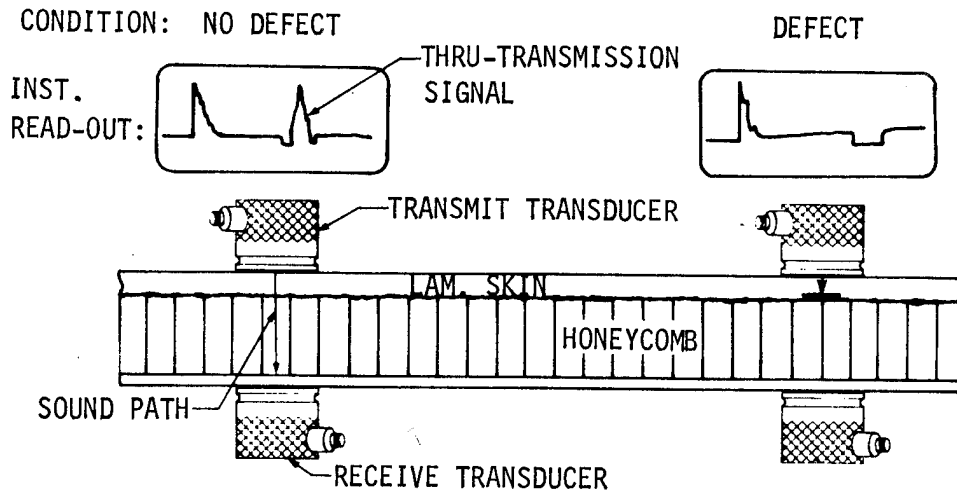
FIGURE 4. THRU-TRANSMISSION TECHNIQUE

Ultrasonic pulses are generated by a "transmit" transducer coupled by water bath, water column to the part surface, or by direct contact with the part surface. The ultrasonic pulses enter the part and travel internally through the part and are detected by a "receive" transducer on the opposite side of the part also coupled to the part in the same manner as the "transmit" transducer. Detectable defects are those that block or reduce sound transmission seen as a loss or reduction in signal amplitude on the instrument readout (see fig. 4).

The through-transmission technique is predominantly used to inspect parts prior to installation on an airplane or after removal from an in-service airplane. With the part removed, it can be submerged in water or placed in a holding device for inspection by water column search units. With this setup, transducers do not contact the part surface and mechanical scanning with "C" scan recording is usually performed over the entire part. Defects are detected as anomalies on the "C" scan recording. However, this technique can also be used on installed parts using one of two methods.

One of these is to manually place one of the transducers in direct contact with the part (using a couplant) and position the other transducer over the opposite surface to obtain a maximum through-transmission signal. This is repeated until the area of interest has been covered. The other method uses a yoke assembly to hold both transducers in constant alignment while scanning the transducers over the area of interest. These methods have been used to inspect limited areas of a given part.

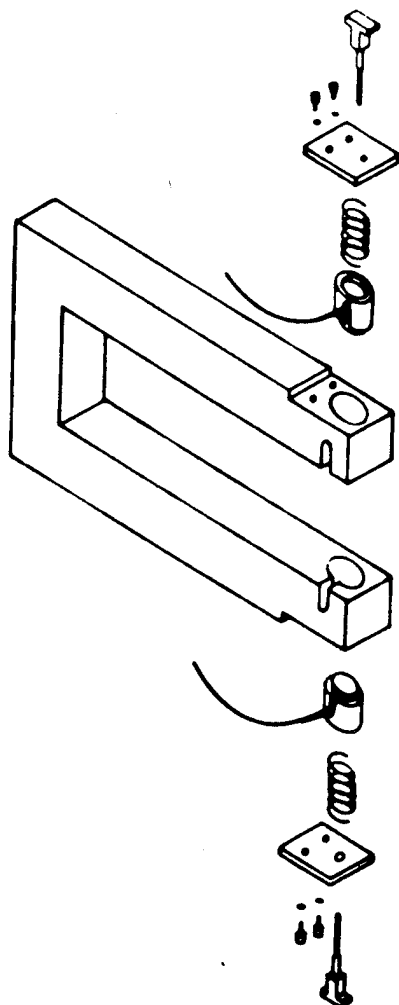
FIGURE 5. YOKE FOR THRU-TRANSMISSION INSPECTION * *(FROM "S-3A GRAPHITE/EPOXY SPOILER DEVELOPMENT PROGRAM, VOL II" JULY 1975, E.G.BLOSSER, ET AL.)

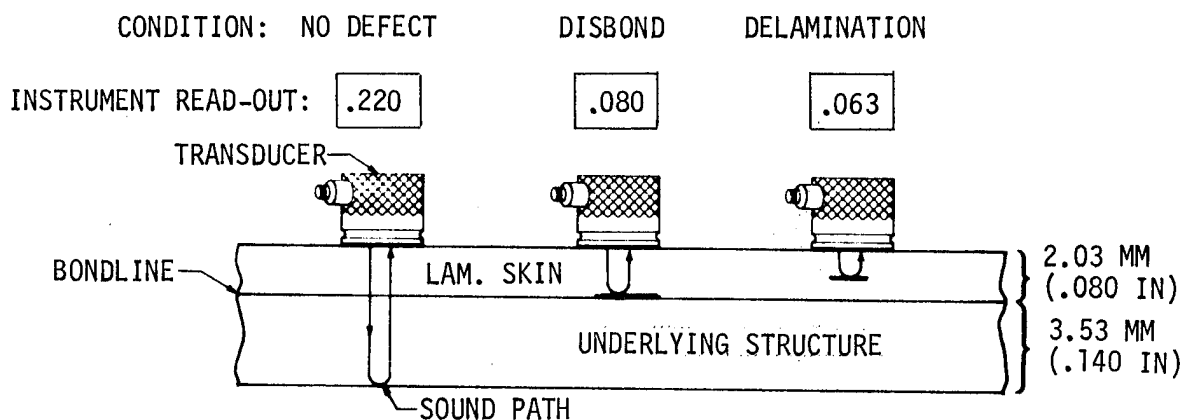
FIGURE 6. DIGITAL THICKNESS GAGE METHOD

This method uses the pulse-echo principle wherein a transducer in contact, through a couplant, with the part surface generates a pulse that travels to the opposite surface of the laminated skin, echoes from this surface, and returns to the transducer. The time interval from pulse initiation to its return to the transducer is measured electronically and presented as the part thickness on a digital readout. This method detects delaminations in a laminate and may detect disbonds if the skin-to-underlying structure bond permits the pulse to pass into the underlying structure. It is illustrated in figure 6.

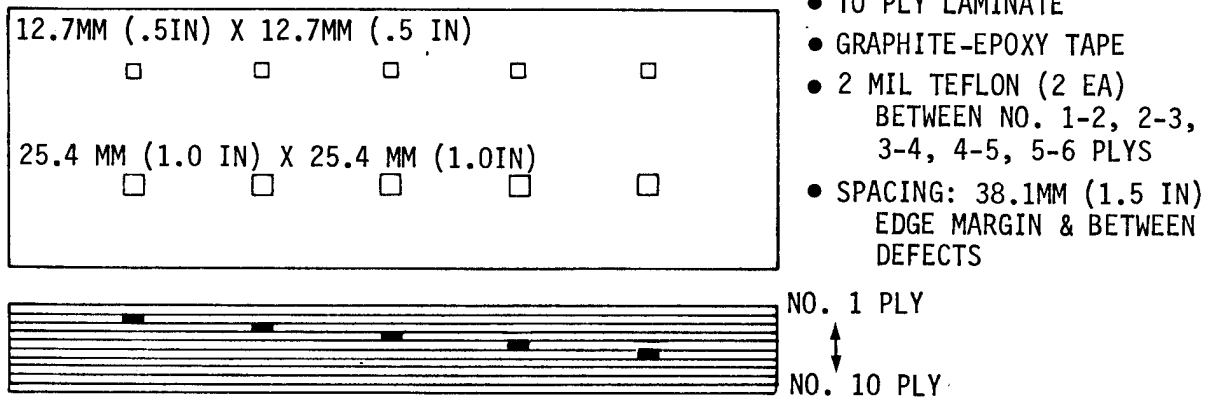
FIGURE 7. TYPICAL GRAPHITE-EPOXY DELAMINATION AND DISBOND REFERENCE STANDARD

These are suitable for standardization of ultrasonic pulse-echo and through-transmission, bond test, and validation of tap test methods. They are fabricated by placing Teflon tape, mylar-covered porous filter material, Tedlar, precured adhesive, or prepreg tape in the bondline and between plies of a laminated part. The size is determined by the defect allowables criteria and shape may be either round or square. Figure 7 is typical. Step wedge thickness standards are illustrated in figure 8.

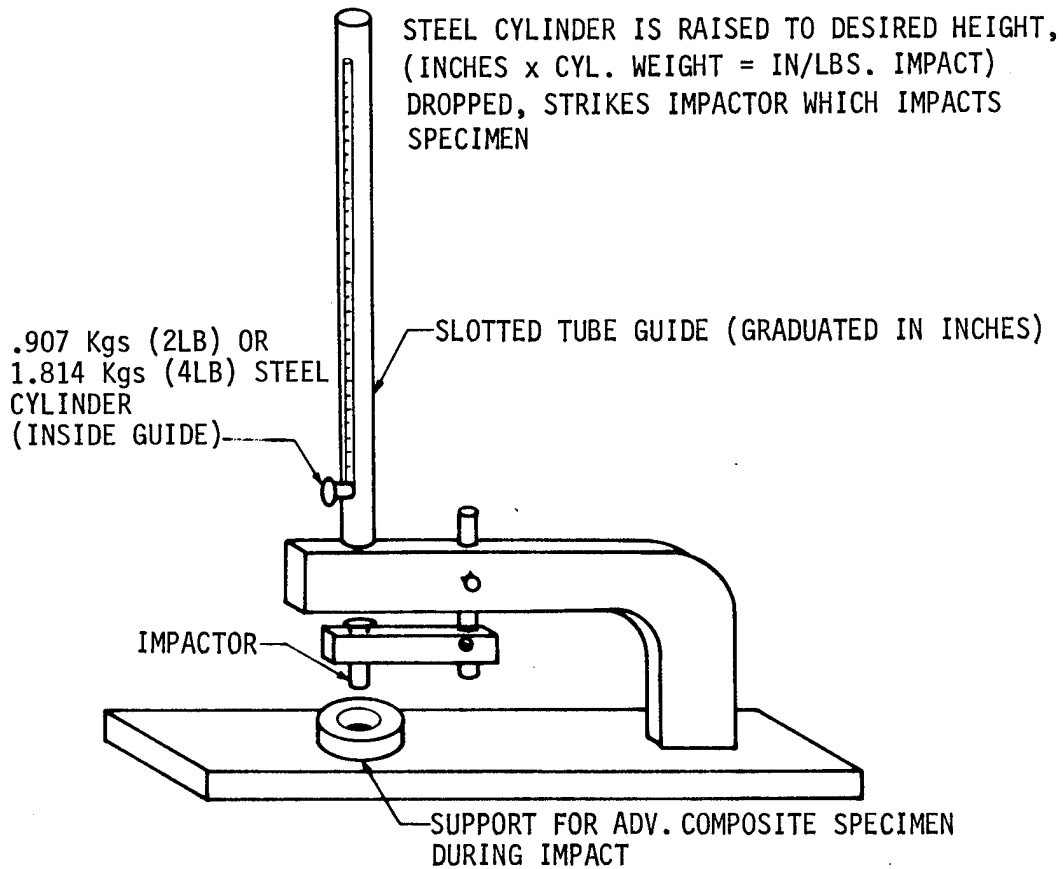
FIGURE 9. METHOD TO ACCOMPLISH CONTROLLED IMPACT DAMAGE

Impact Damage: This is created in the laminated skin member by impact of a blunt object with the test standard surface. A typical method is illustrated in figure 9. Impact defects in the reference specimen should range in severity up to visible damage. The nonvisible defects are used to verify sensitivity of ultrasonic, bond tester, and tap test methods.
